This gallery shows some pictures of bad solderings - they should prevent you from making the same errors (feel free to add even more pictures here!)

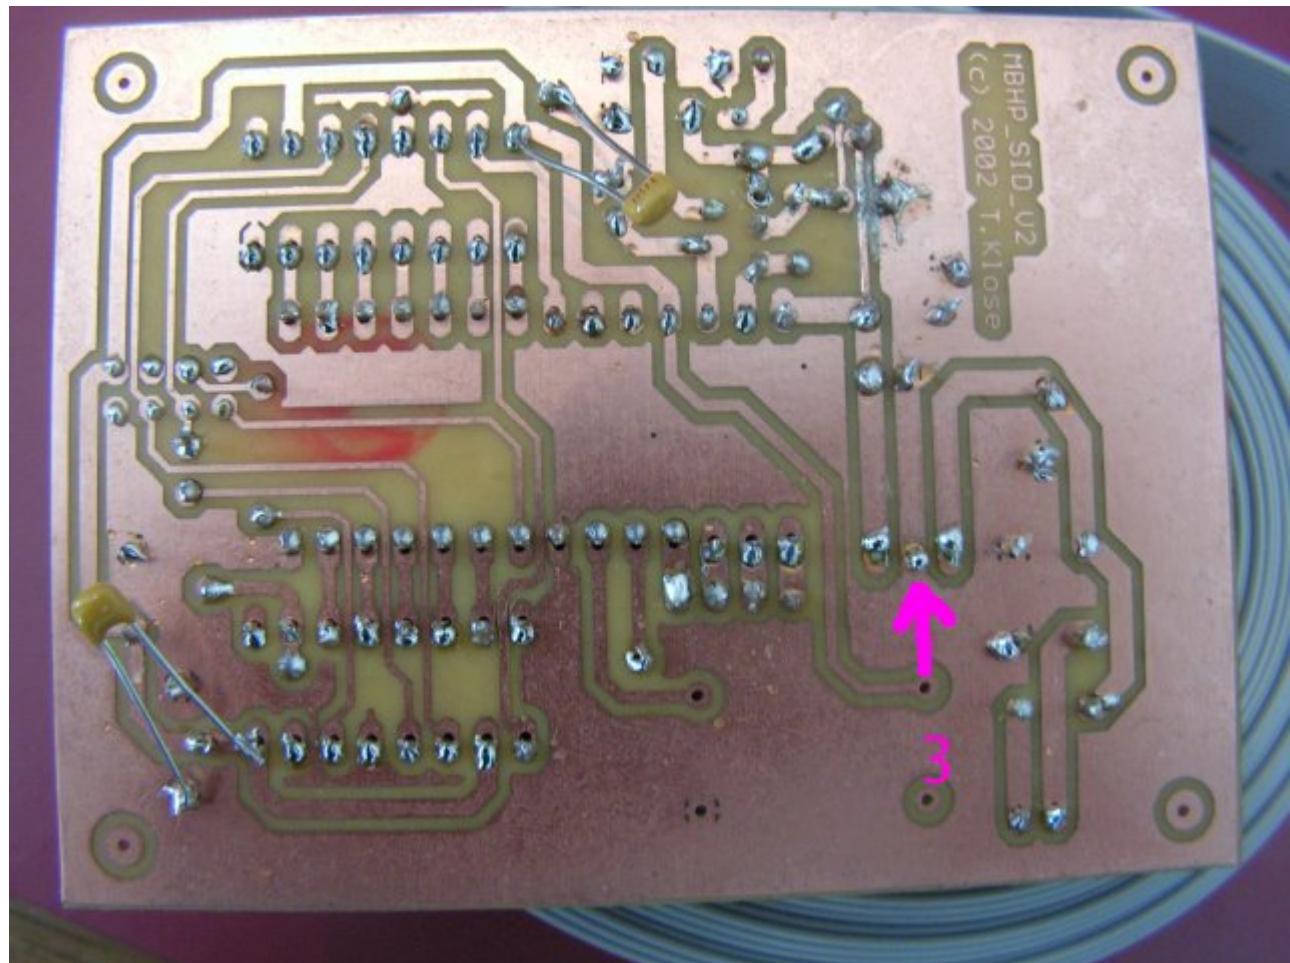
3: This seems to be a bad ground connection directly at the 78xx - it can lead to the wrong voltage. Here the same: just solder the pads again, it will help

And same as above: the long cap legs need to be cut, the danger of shorting out is too high!
