This gallery shows some pictures of bad solderings - they should prevent you from making the same errors (feel free to add even more pictures here!)

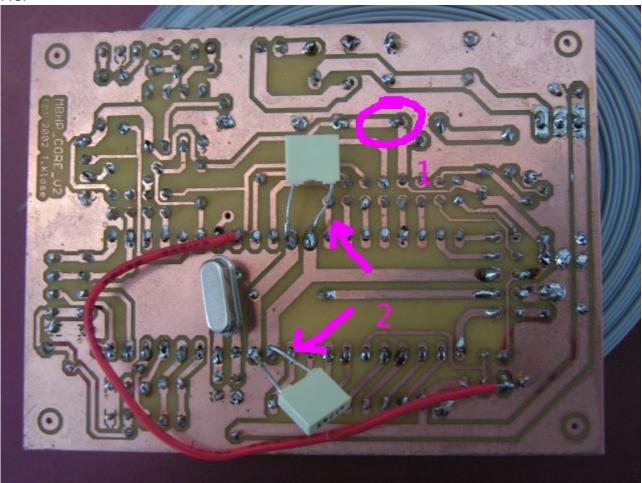
- 1: The core module has some badly soldered connections(loose), which could lead to failures. There are also missing solderings (e.g. 33pF cap below crystal). It makes sense to solder each pad again, the Soldering guide in the Wiki gives some useful tips
- 2: The legs of the caps should be cut, otherwise they can cause a short circuit which can damage the PIC!

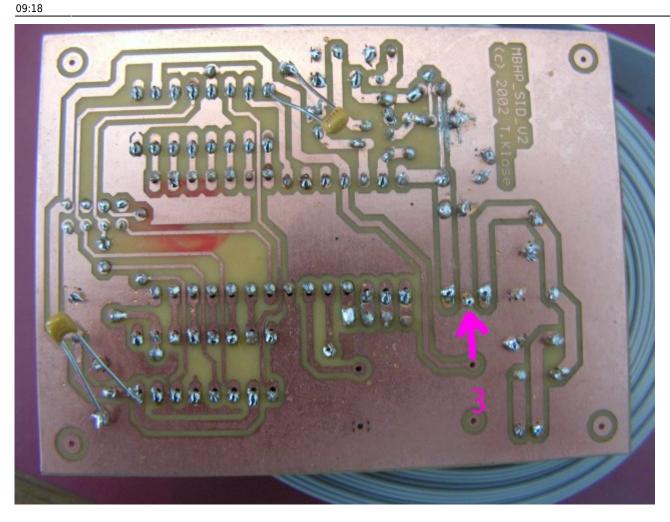
3: This seems to be a bad ground connection directly at the 78xx - it can lead to the wrong voltage. Here the same: just solder the pads again, it will help And same as above: the long cap legs need to be cut, the danger of shorting out is too high!
