This gallery shows some pictures of bad solderings - they should prevent you from making the same errors (feel free to add even more pictures here!)

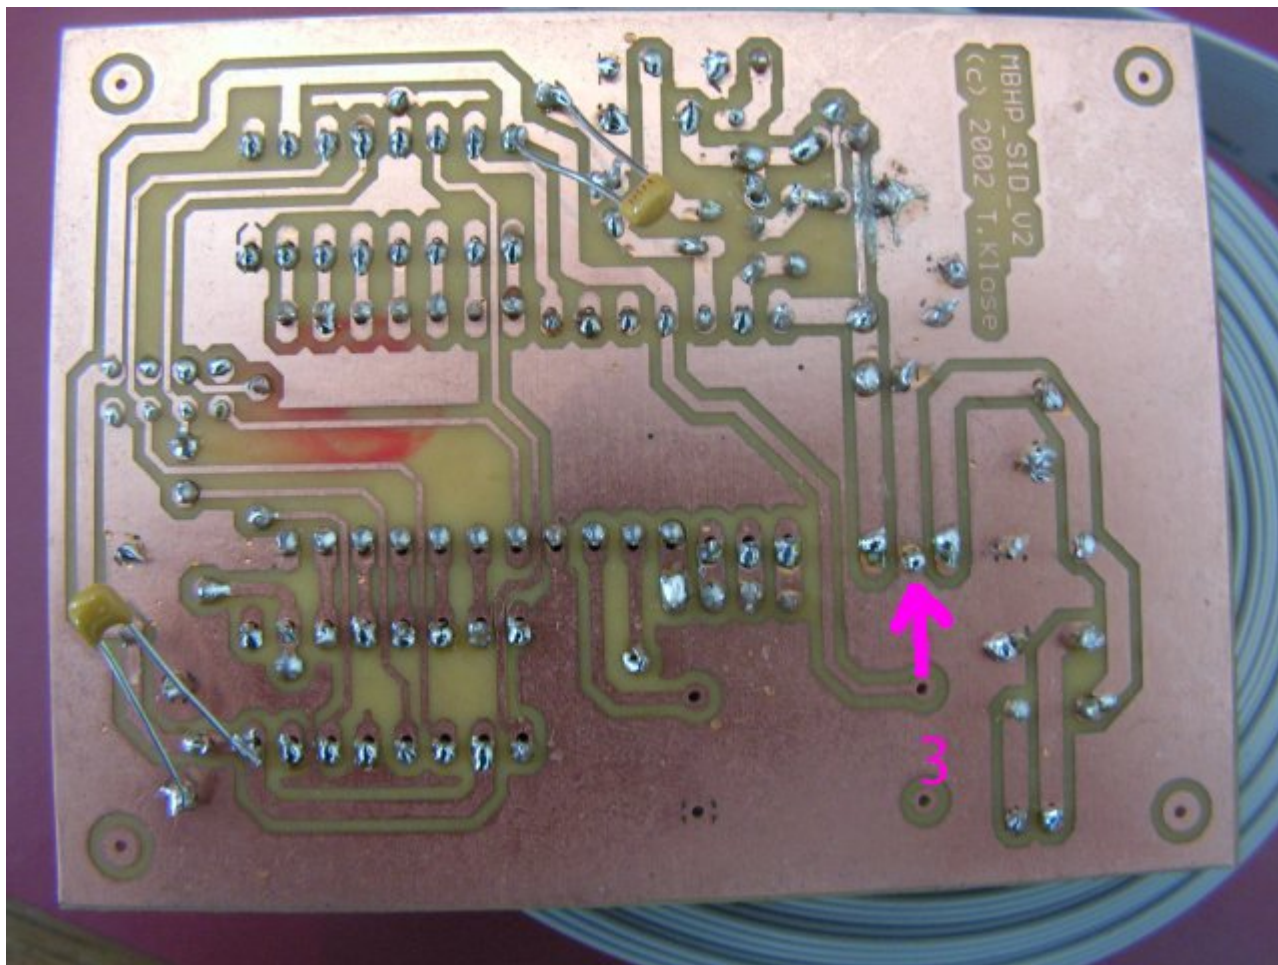
3: This seems to be a bad ground connection directly at the 78xx - it can lead to the wrong voltage. Here the same: just solder the pads again, it will help  
And same as above: the long cap legs need to be cut, the danger of shorting out is too high!
