This gallery shows some pictures of bad solderings - they should prevent you from making the same errors (feel free to add even more pictures here!)

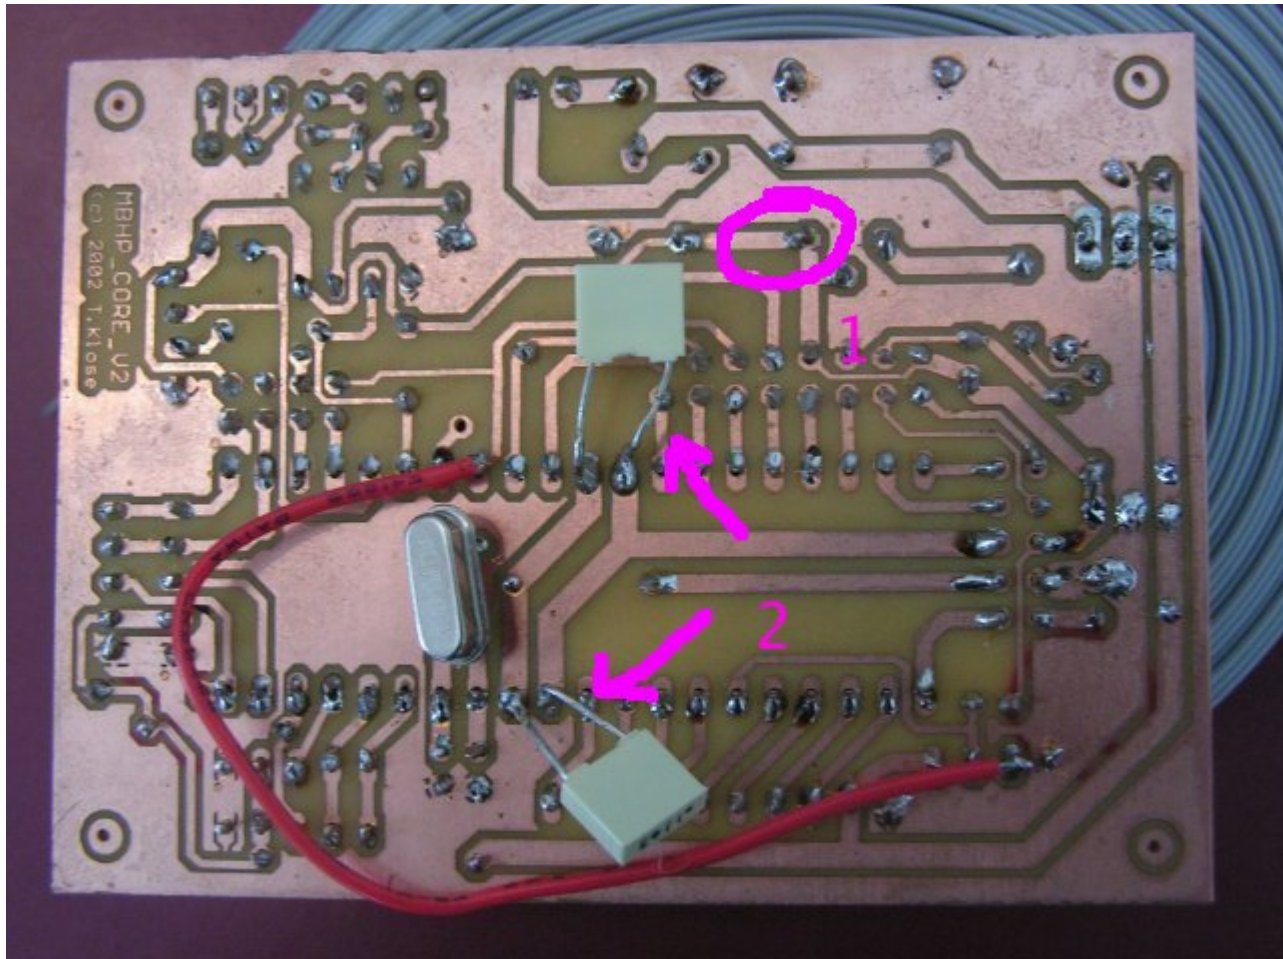
1: The core module has some badly soldered connections(loose), which could lead to failures. There are also missing solderings (e.g. 33pF cap below crystal). It makes sense to solder each pad again, the [Soldering](#) guide in the Wiki gives some useful tips

2: The legs of the caps should be cut, otherwise they can cause a short circuit which can damage the PIC!
