This gallery shows some pictures of bad solderings - they should prevent you from making the same errors (feel free to add even more pictures here!)

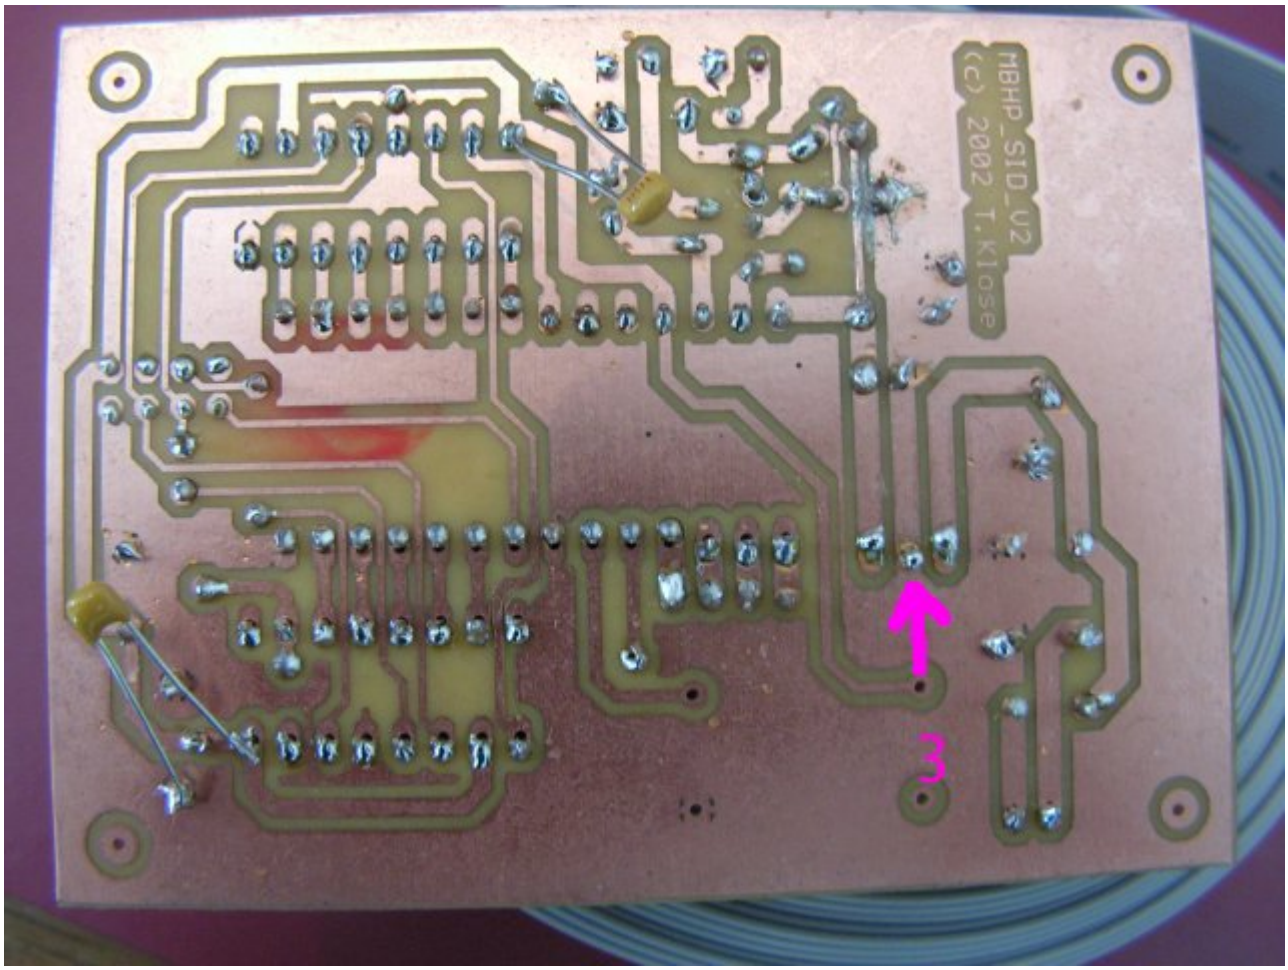
3: This seems to be a bad ground connection directly at the 78xx - it can lead to the wrong voltage. Here the same: just solder the pads again, it will help
And same as above: the long cap legs need to be cut, the danger of shorting out is too high!
