This page lists the known errors on the gm5x5x5 PCBs.

Prototype Run

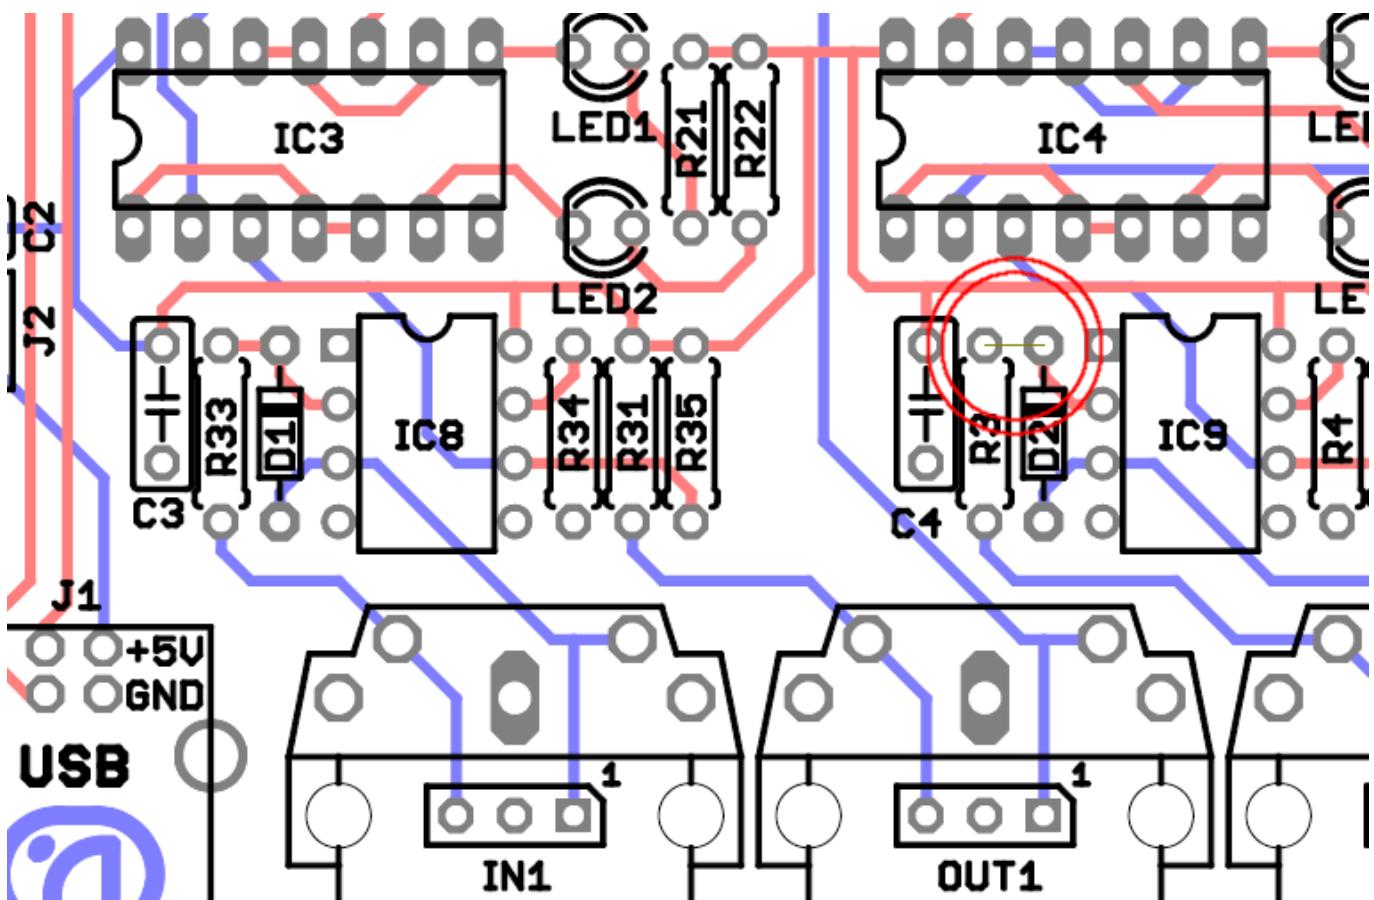
#2 MISSING TRACK

Problem: A track between D2 and R3 is missing.

Solution: Bridge the pins.
